**REVISED
MINE RECLAMATION PLAN
FOR THE
RED HILL QUARRY
CA MINE ID: 91-14-0002**

**Updated
January 2021**

**Amended Reclamation Plan for Red Hill Quarry (CA Mine ID 91-14-0002)
Rose Valley Area, California**

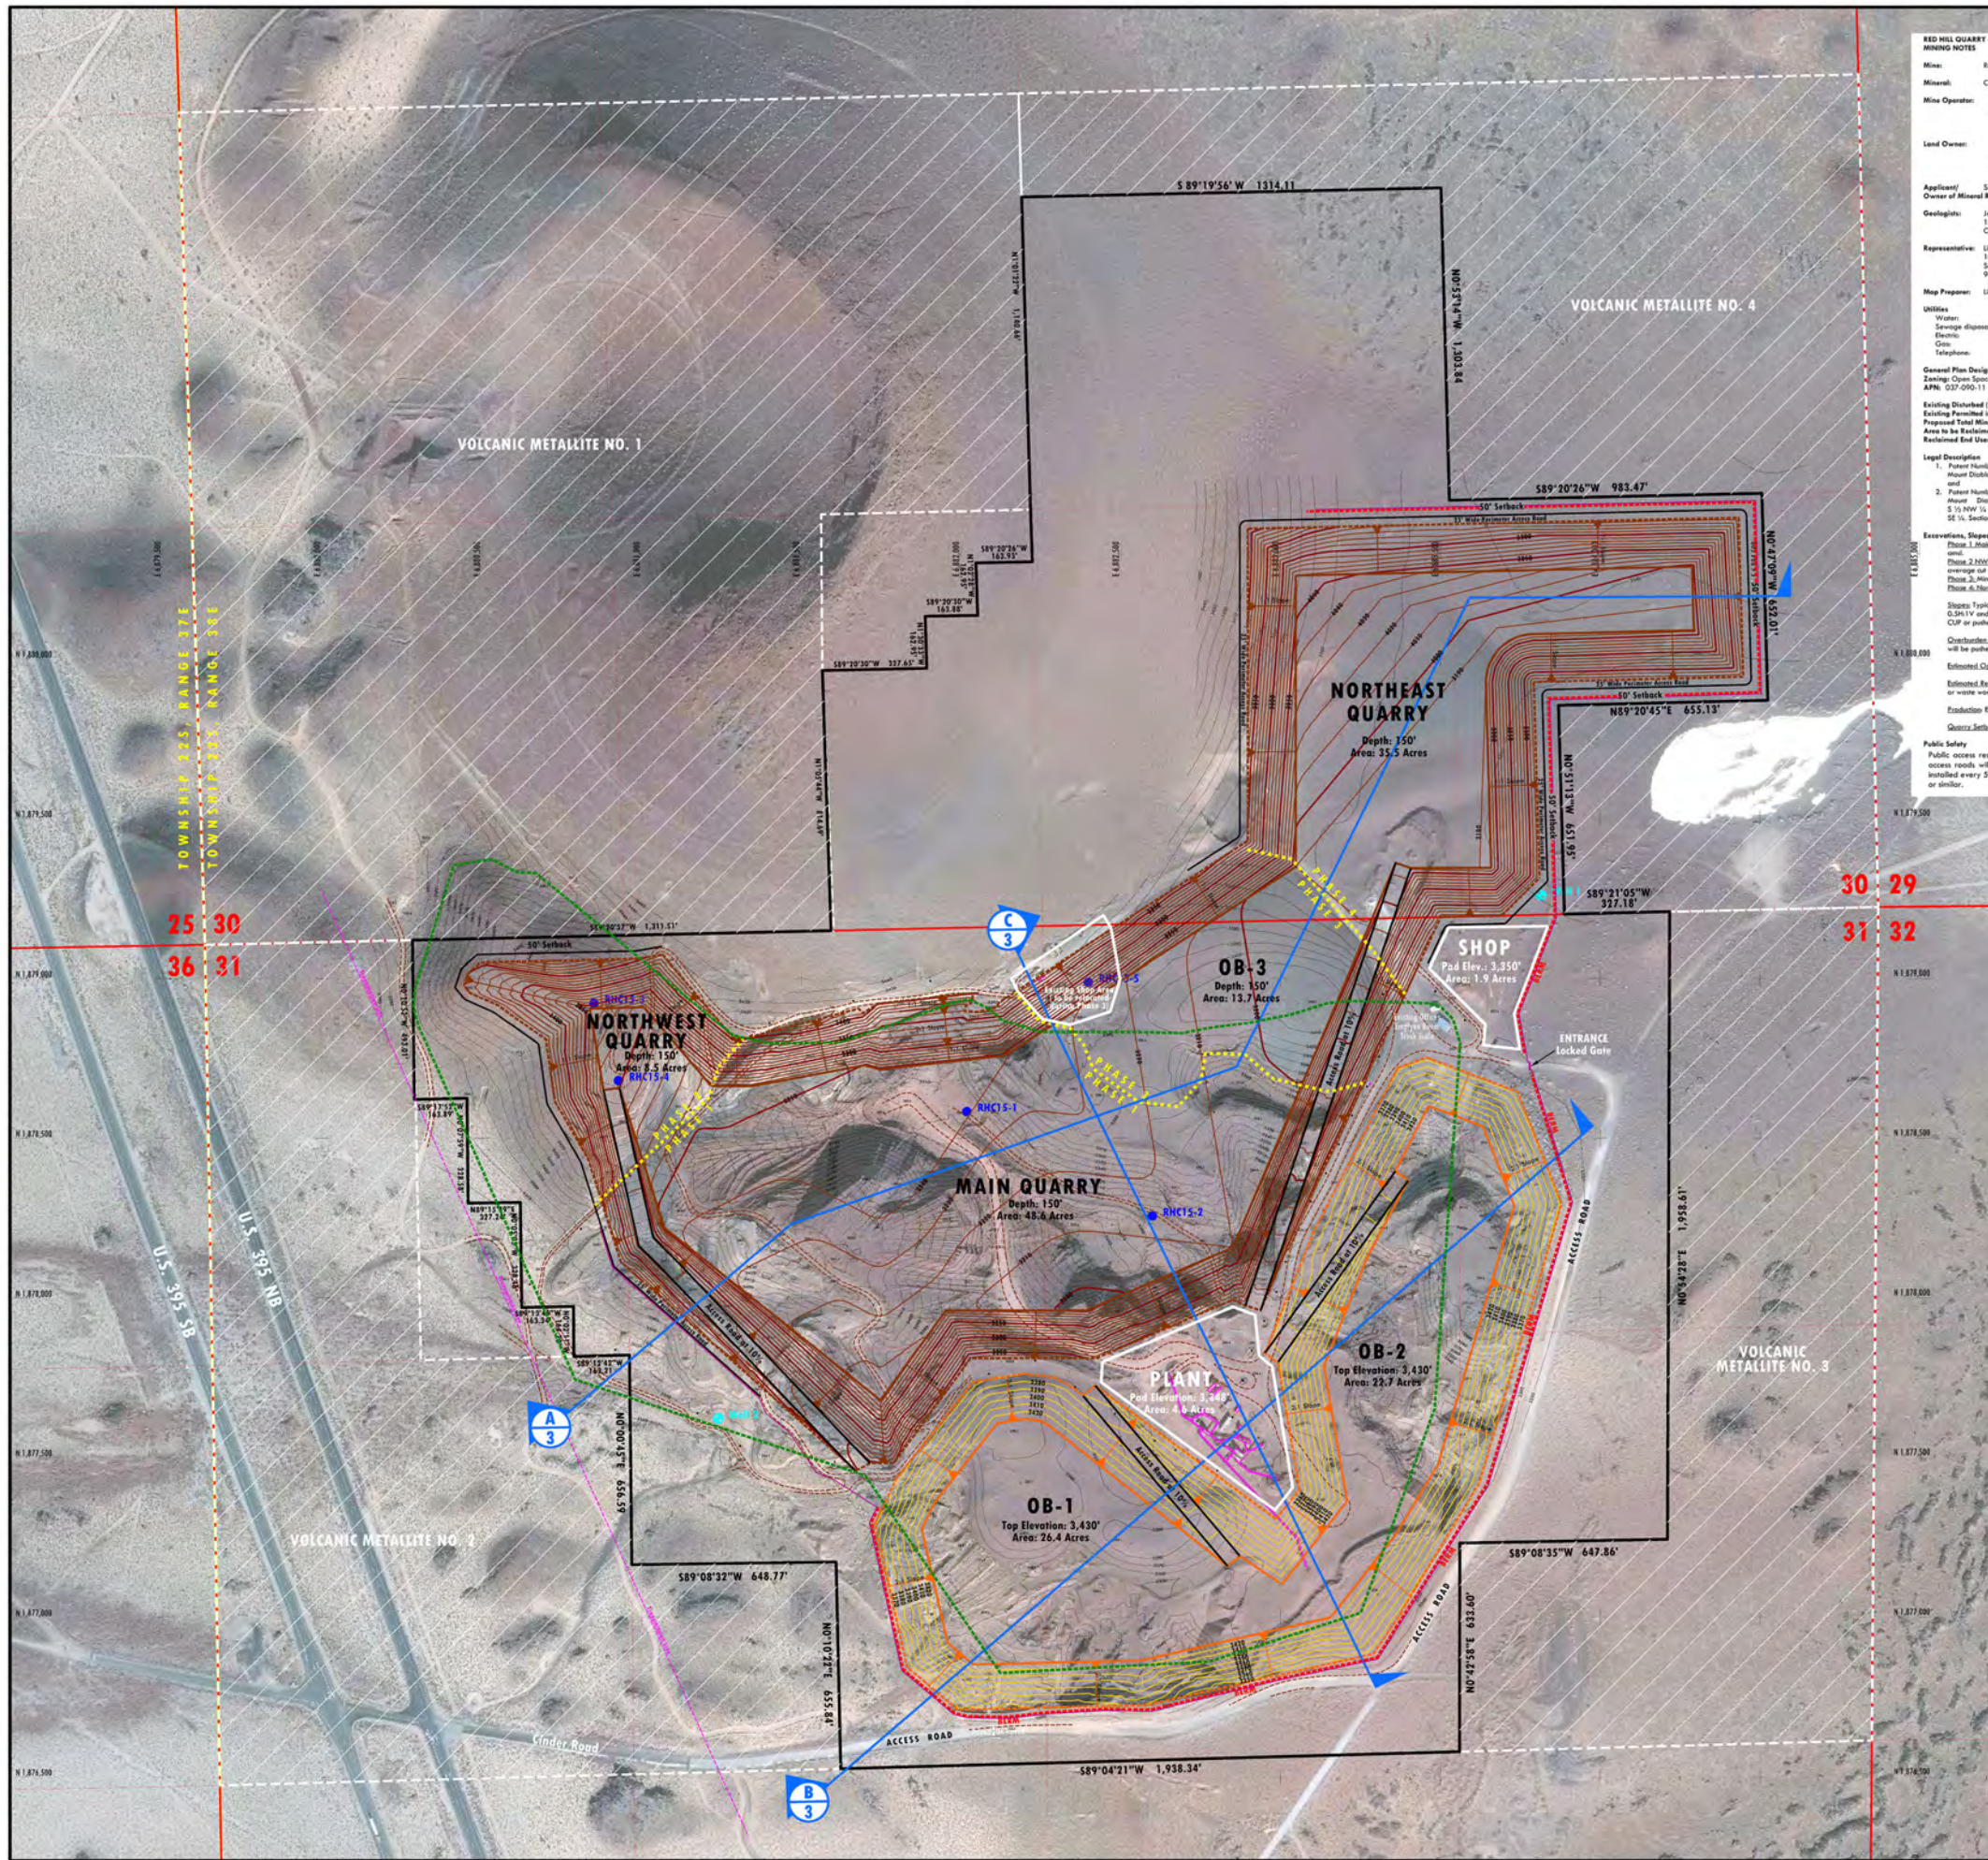
RED HILL QUARRY - CA MINE ID# 91-14-0002
MINING NOTES

Slopes: Typical 1H:1V. Benches: 15 feet horizontal, 20 feet height with 80' max. face. Active slopes may be as steep as 0.2H:1V and cut back within circles as feasible to a reclaimed slope of no more than 1H:1V as required by the current CUP or pushed down/backfilled with native material to 2H:1V as recommended by Terrason.

Please refer to Figures 3 and 4 and Sheets 1 and 3 to review the Mine Plan and Cross Sections and Table 1 for a listing of the phases and facilities' existing and proposed areas. Mining operations will be undertaken in four phases with time frames dependent on production needs and material quality and quantity. Phases 1, 2 and 3 are essentially implementing the existing 1979 CUP and its conditions of approval. Phase 4 will extend mining to the northeast by 35.5 acres; east of the cinder cone proper in the future. Total area expansion will be approximately 46 acres. The conditions of approval relevant to ongoing and future operations being implemented by TMRV include among others:

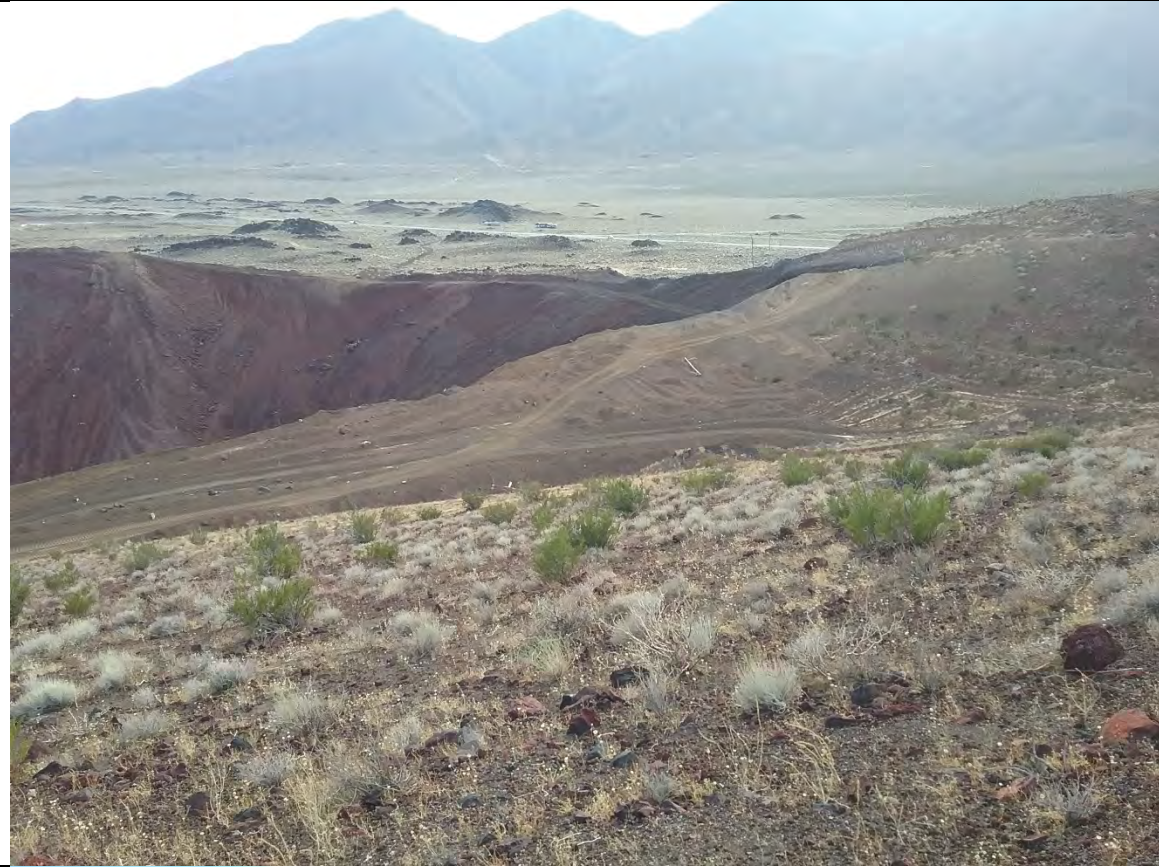
Photo 1. Looking west at the south westernmost portion of the project site from the southern slope of Red Hill; adjacent the existing mining operation.

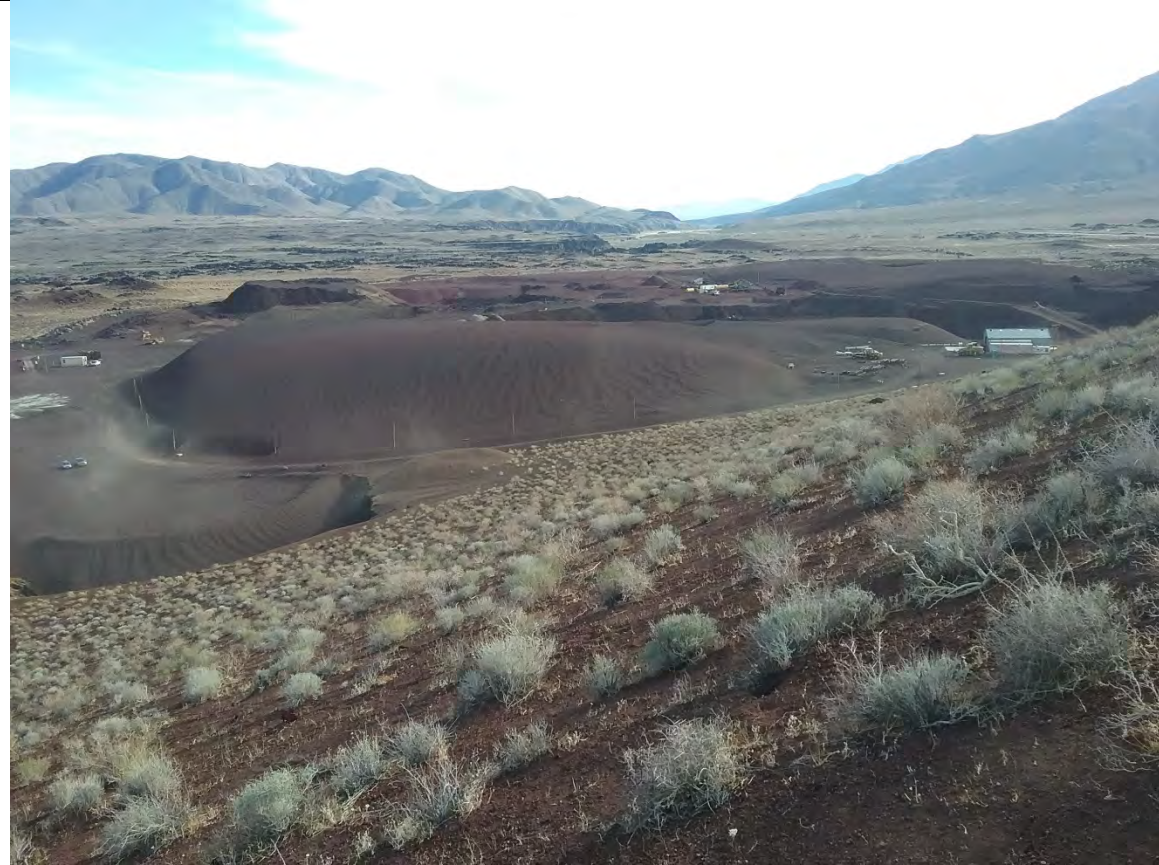
Photo 2. Looking south at the southern portion of the project site from the eastern slope of Red Hill. Existing mining operation in the far ground, south of the project site.

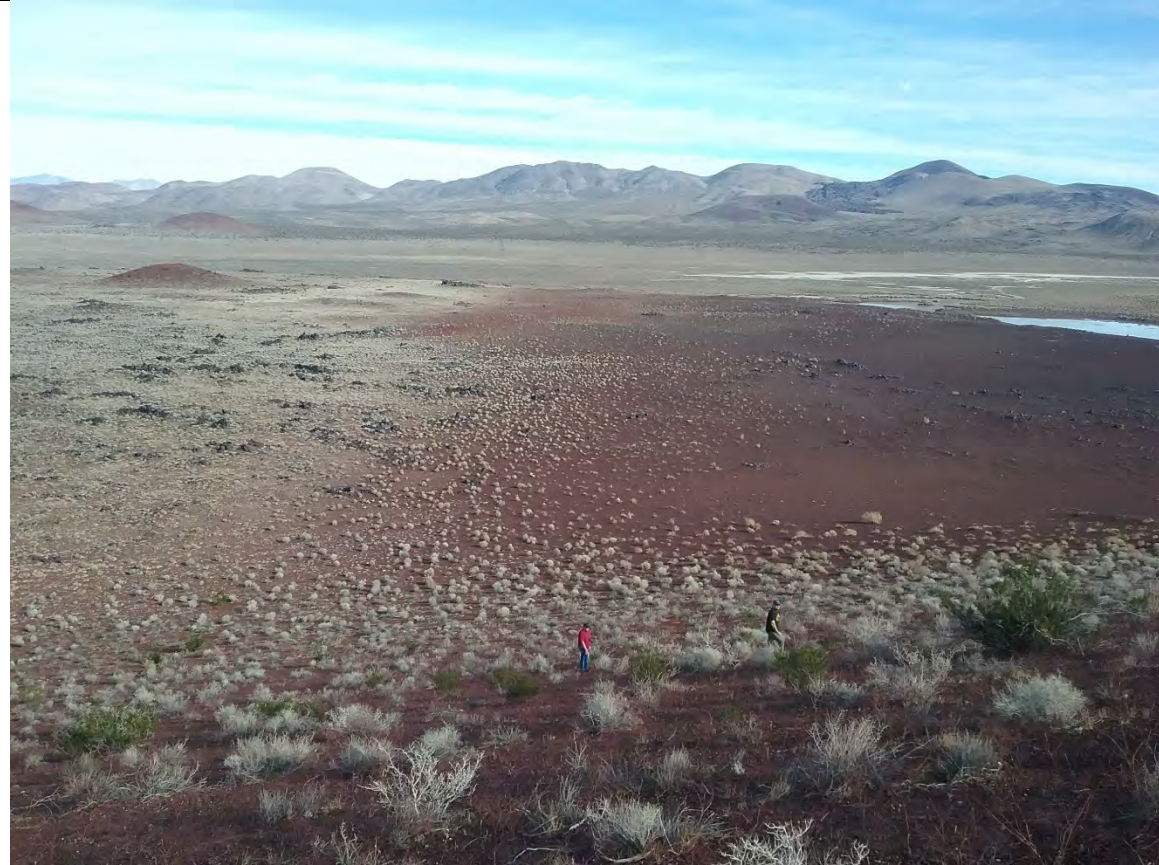
Photo 4. Looking east at the northernmost portion of the project site and adjacent habitat from the eastern slope of Red Hill.

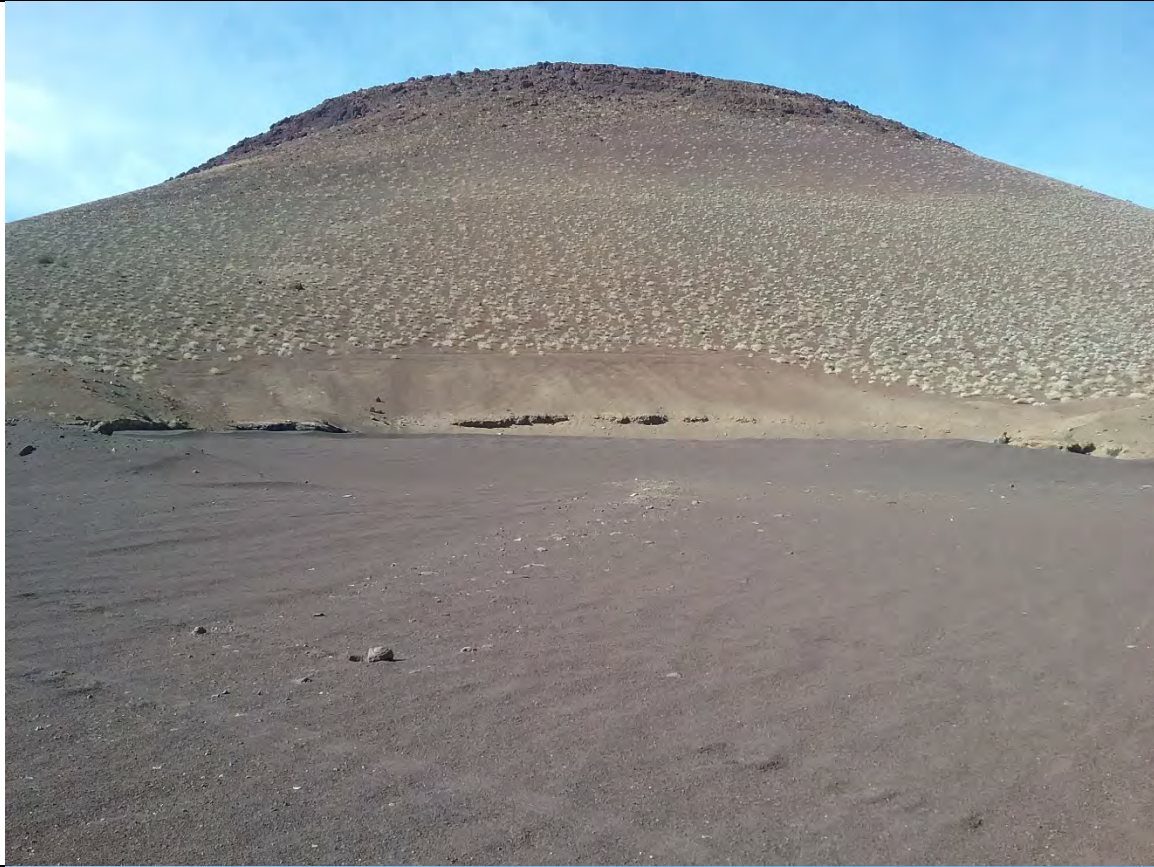
Photo 5. Looking west at Red Hill and the westernmost portion of the project site, which is situated along the lower slope of Red Hill.

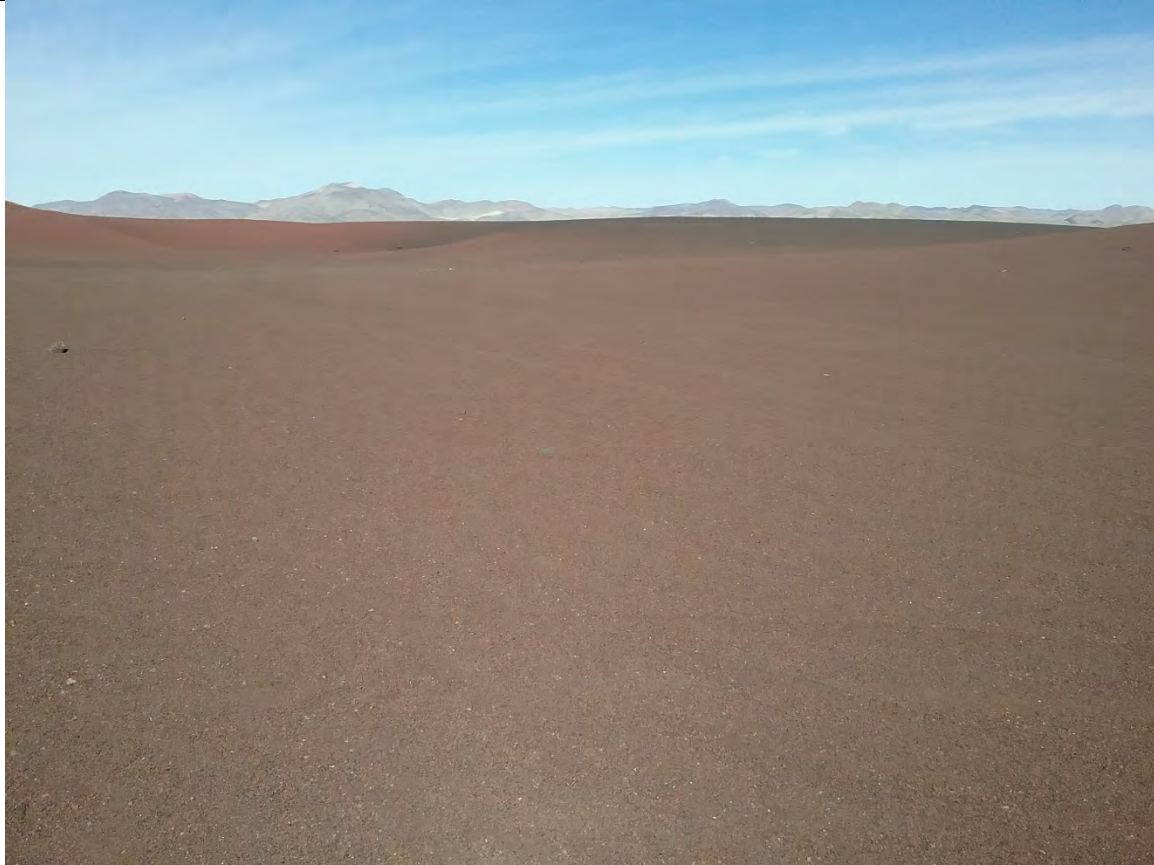
Photo 6. Unvegetated middle portion of the project site.

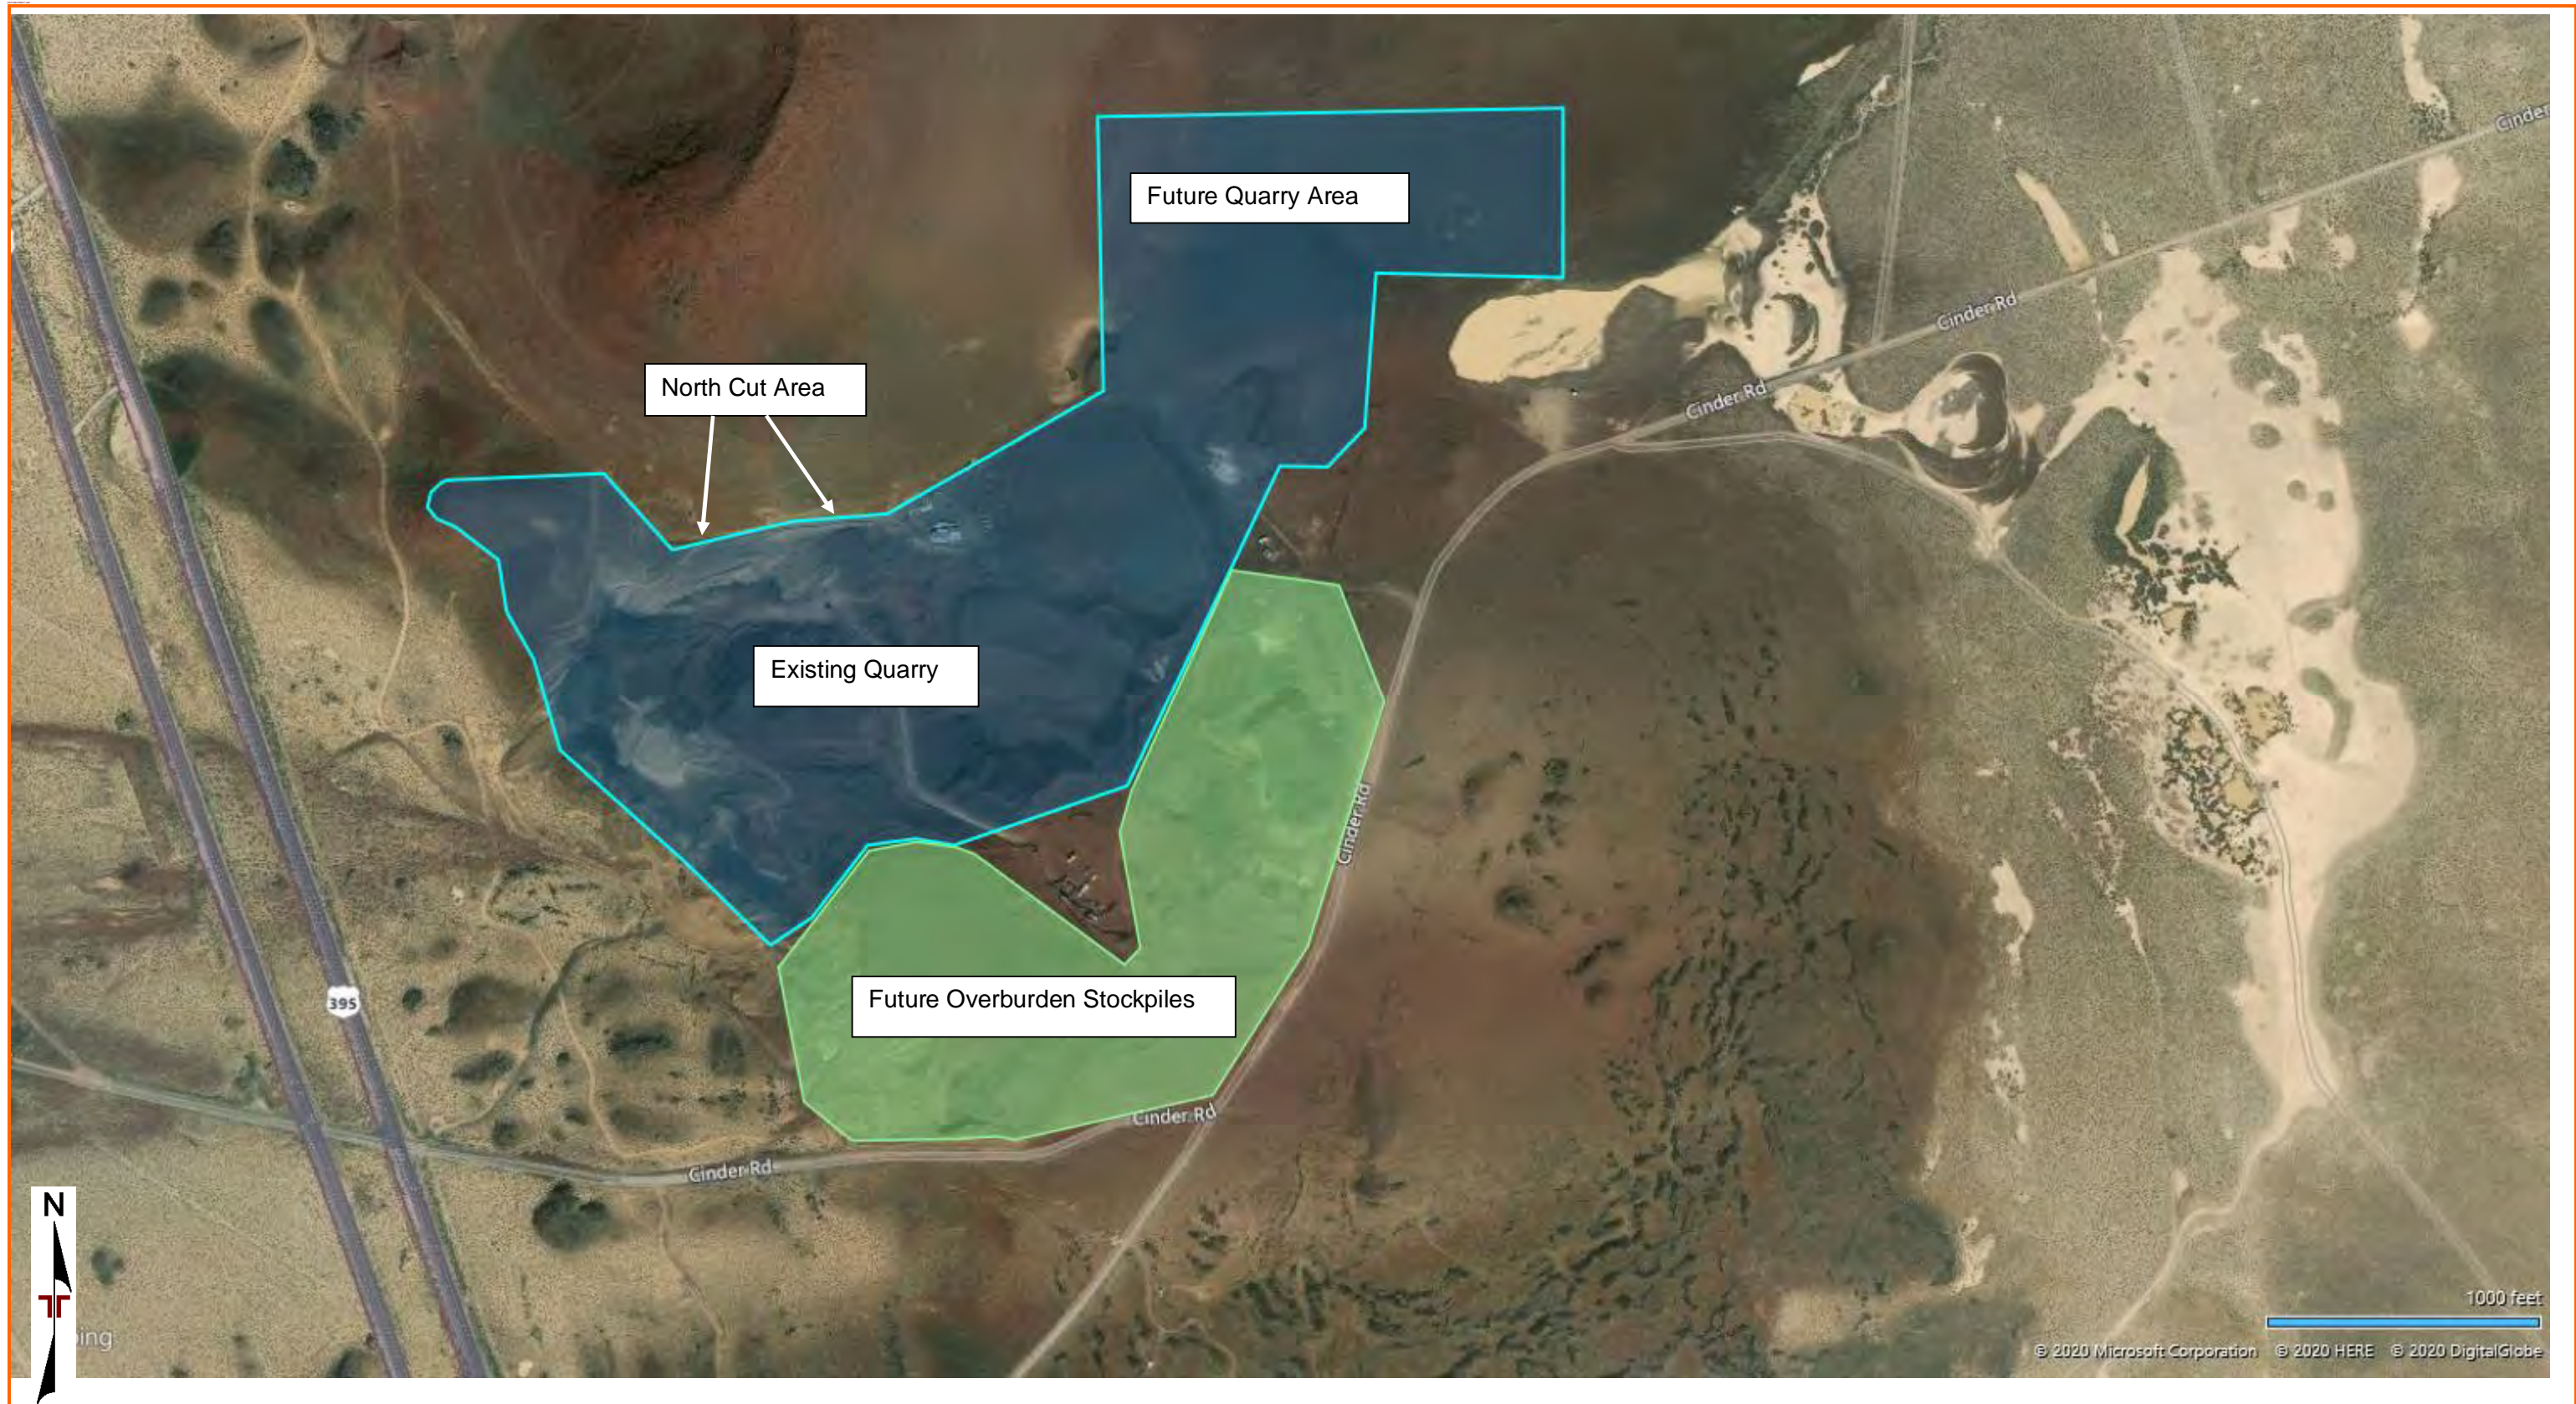
Red Hill Mine North Highwall - Geological Structural Data				
No.	Dip	Dip Direction	Continuity	Type
1	59	017	2	Bedding
2	52	001	2	Bedding
3	48	011	2	Bedding
4	22	074	3	Bedding
5	19	072	3	Bedding
6	74	179	3	Joint
7	71	188	3	Joint
8	71	205	3	Joint
9	89	296	1	Joint
10	82	293	1	Joint
11	64	240	2	Joint
12	87	121	1	Joint
13	53	112	3	Joint
14	76	112	1	Joint
15	87	123	1	Joint
16	87	124	1	Joint
17	82	252	3	Joint
18	82	264	3	Joint

* C1 - discontinuous (less than 3 ft.); C2 - slightly continuous (3 to 10 feet); C3 - moderately continuous (10 to 30 feet); C4 - highly continuous (30 to 100 feet); C5 - very continuous (greater than 100 feet).

Bedding planes exposed in limited cut slopes within the main pit area were measured to dip northward and eastward at angles of 50 to 60 degrees and 20 degrees, respectively. East dipping bedding was measured on a formerly-buried lava flow resting in contact with a cone flank. Bedding can be anticipated to vary throughout the site as construction of a volcanic pile is a somewhat random process that includes liquid material flow and air-fall actions. A northeast striking, steeply dipping joint set dominated the structure of the north highwall area. A 70-degree southward dipping joint system was also noted. The cinder material is anticipated to exhibit relatively homogeneous materials properties at the proposed 1H:1V cut slope angle.

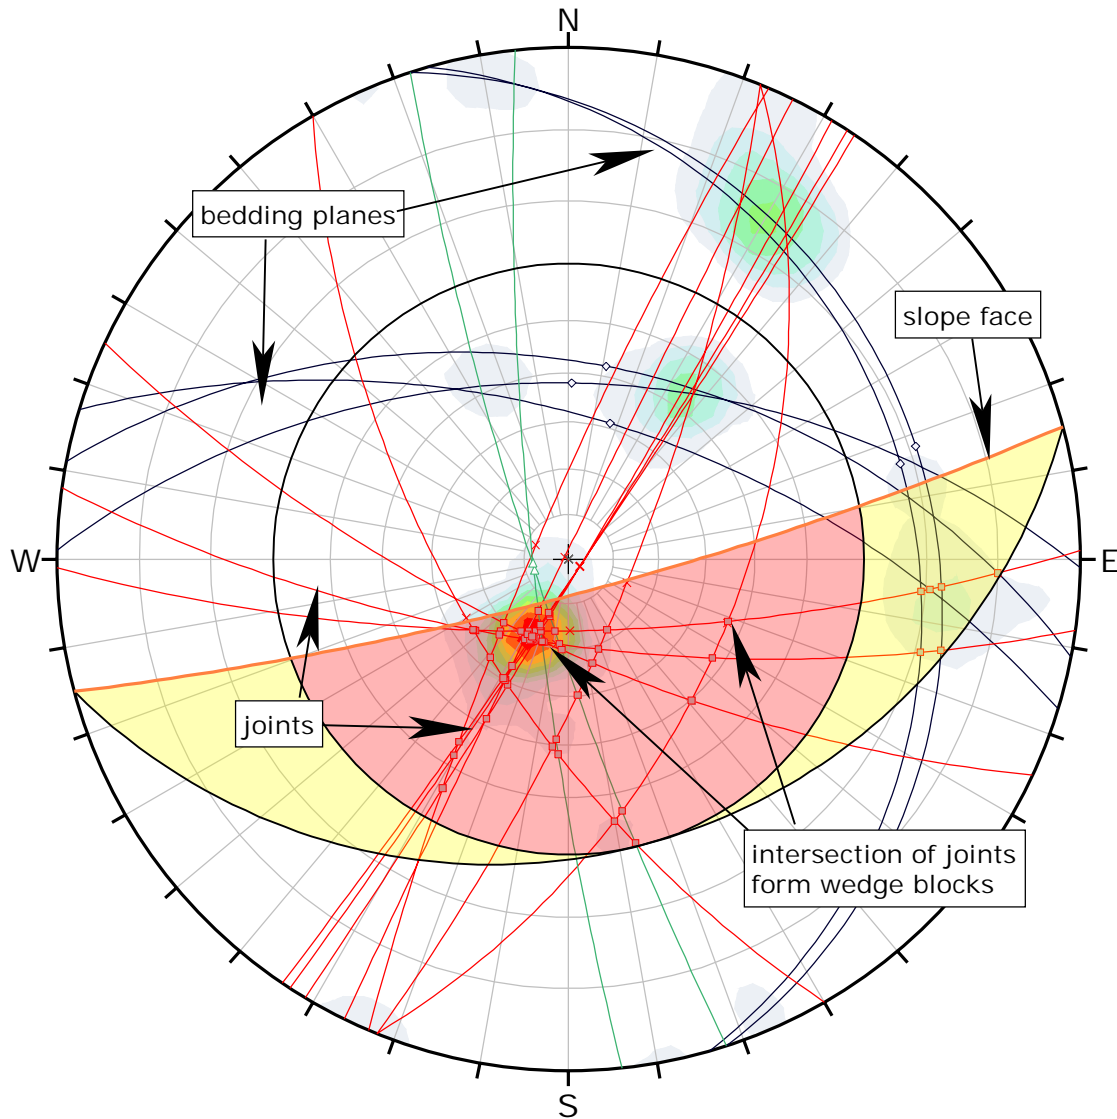
Project	Red Hill Quarry		
Analysis Description	Kinematic North Cut		
Drawn By	Terracon	Author	JMc
File Name	wedge Dips Data.dips7	Date	6/10/2020

Symbol	TYPE	Quantity
◇	Bedding	5
×	Joint	11
△	Plane Type 1	2
Symbol	Feature	
■	Critical Intersection

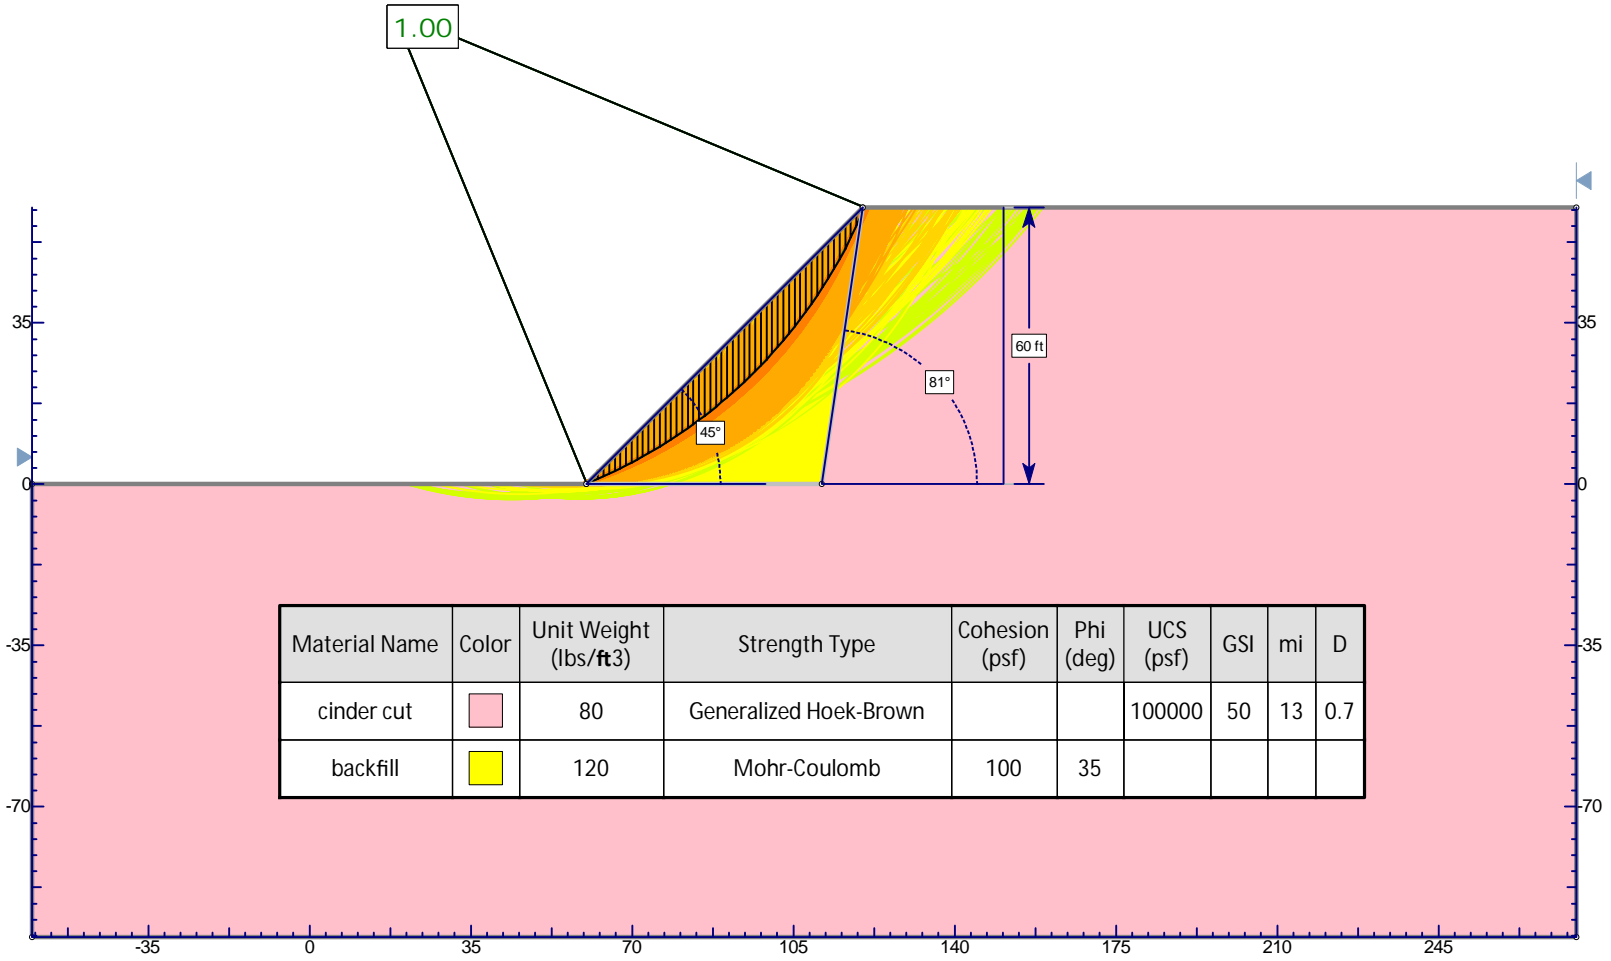
Project	Red Hill Cinder Mine		
Analysis Description	Backfill Slope		
Drawn By	JMc	Company	Terracon
Date		File Name	red hill rec slope 1to1 fill against cut.slmd

Material Name	Color	Unit Weight (lbs/ft ³)	Strength Type	Cohesion (psf)	Phi (deg)	UCS (psf)	GSI	mi	D
cinder cut

The planned backfill slope configured at 1(H):1(V) does not exhibit sufficient Factors of Safety under static and seismic conditions for use in reclamation according to DMR. Therefore, an alternative model using backfill at 2(H):1(V) was analyzed and determined to meet recommended factors of safety. Therefore, any final quarry slopes that cannot be flattened to 1H:1V by cutting into native basalt and cinder shall be backfilled at 2H:1(V).
