## Death Valley Updates—Flood Recovery 2015

Update for Tuesday, November 17:

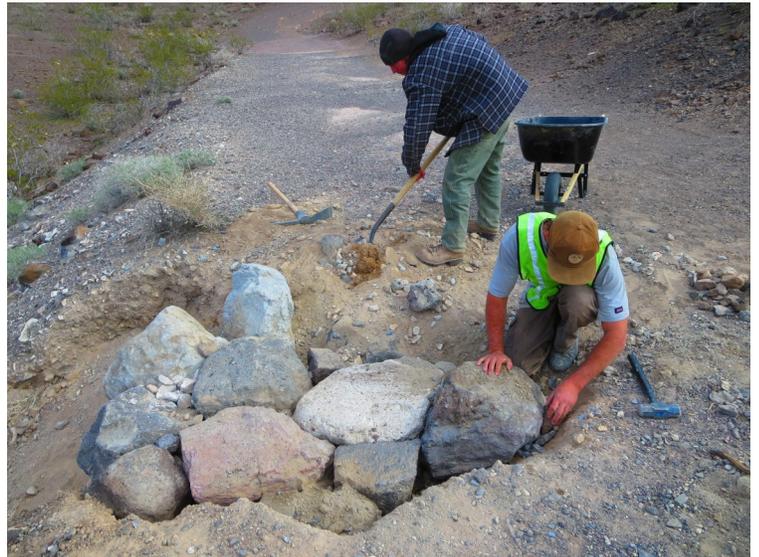
*The crew from Yosemite National Park removed debris and repaired the trail leading to Death Valley Scotty's grave on Monday. NPS photo by Danie Dawson.*

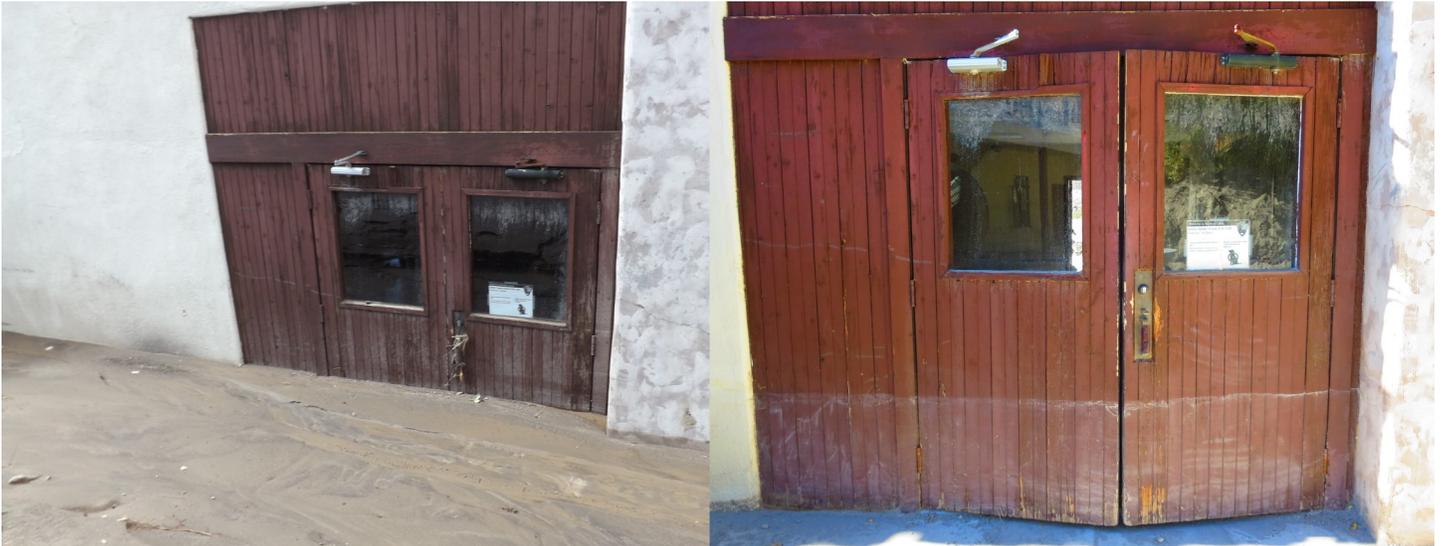
More improvement at Scotty's Castle, as hand crews have completed the removal of two feet of mud and silt the exterior of the visitor center. NPS photos by Danie Dawson.

- *Visitor Center and Hacienda office buildings:* Several feet of water flowed through these buildings, leaving behind 1-4 feet of mud. A structural wall in the visitor center (historic garage) was displaced due to the force of floodwater. All carpets, drywall, exhibits, utilities, and office equipment has been removed and will need to be replaced. The inventory and fixtures of the bookstore has been lost. Walls will require inspection for structural integrity.
